# HIGH AND DRY

Is your home watertight? Dennis Gehman of **Gehman Design Remodeling** explains how to avoid costly repairs resulting from rain-related water damage.

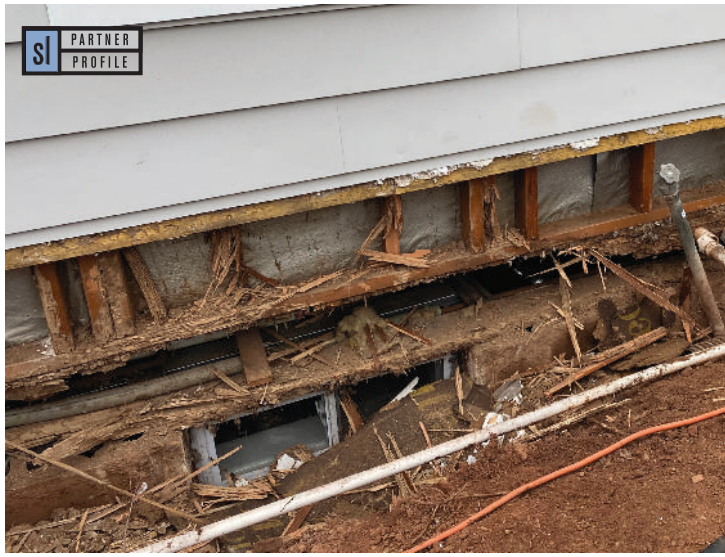
Water caused significant damage to the home of this Gehman Design Remodeling client in Harleysville.

"The whole yard on that side of the house was way too high," Gehman says. "The soil around the house was 8 inches over the wood framing that was covered with stucco, which is not watertight, and it had probably been that way for 30 to 40 years. That resulted in substantial rot in the floor joists, and the subfloor above had gone soft. Once the water gets in there, it draws in insects that like to chew on and burrow into the wood, and that degrades it even more."

To amend the problem, Gehman and his team had to remove much of the existing siding and perform extensive surgery on the house's "bones": extracting the rotten or otherwise affected parts of the structure; replacing the studs using pressure-treated wood; and adding self-adhering Ice and Water Shield for water-tightness, as well as a layer of aluminum sheathing for an "extra measure" of protection.

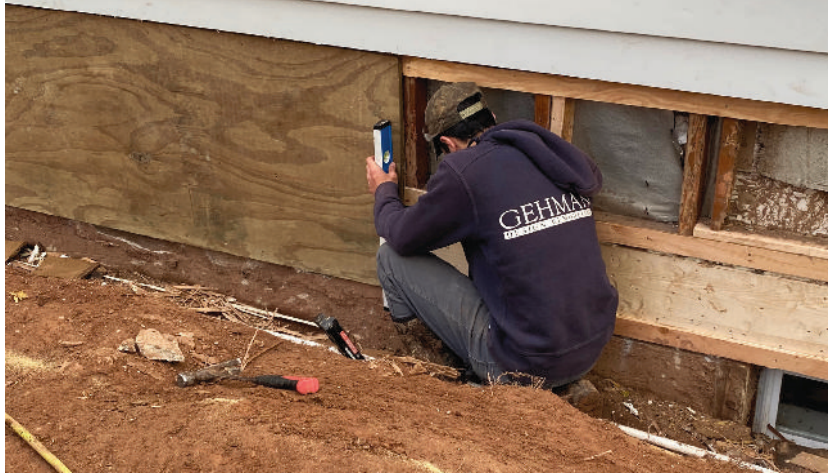
Gehman's team installs pressure-treated sheathing as part of its solution to fix the damage.
